# Audit of Chennai Waterways – A Citizen's Report

**Is Chennai ready to face the  
upcoming monsoon?**

**August 2016**

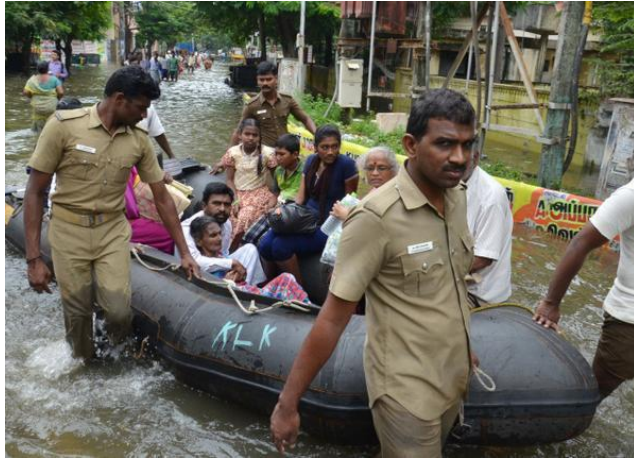
SIDCO nagar in 2015 floods

SIDCO nagar in Villivakkam was one of the heaviest flooded places in Chennai and the area continued to be deeply inundated for more than a week after the December floods. Villivakkam lake is one of the lakes that has shrunk in size greatly over the decades. In 1972, this waterbody was nearly 214 acres. GIS mapping of today’s lake shows that only 20 acres is left.

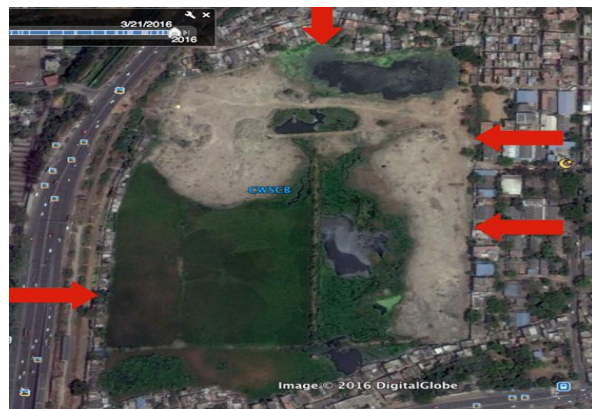
Villivakkam in 2016

almost 80% over the last 3 decades. During the floods in 2005, most of the water drained into the lake and the area did not see a major problem. However, preliminary analysis of the GIS data now revealed that there is some significant encroachment going on in the lake over the last 3 years. Preliminary audit revealed that Metro Rail has been dumping its sand into the lake for the past 3 years shrinking the lake further.

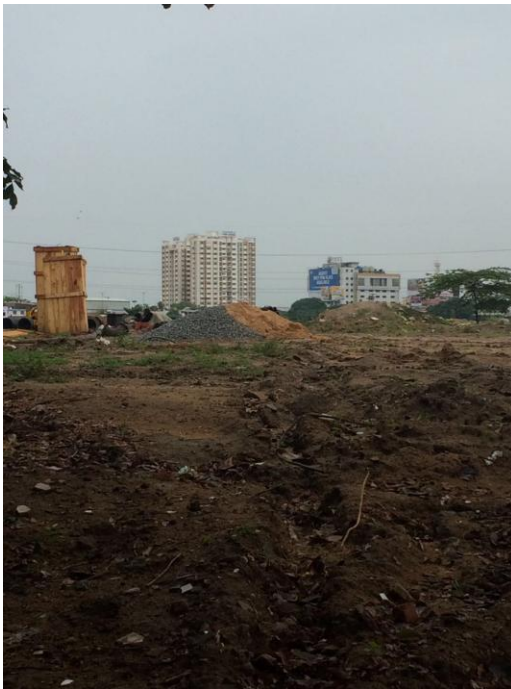
- The lake has been filled up with debris from Metro Rail construction over the past 3 years. The satellite imagery of the Villivakkam lake

Villivakkam lake filled with Metro rail debris

shows clearly that the lake has been filled up with construction debris over the past 3 years. In the social audit, it was clear that the construction debris has been piled up anywhere between 10 to 20 feet above the ground blocking the inlets into the lake.

- Villivakkam lake must be restored immediately. The huge dumping of sand by Metro Rail and encroachment by Metro water Department inside the lake needs to be cleared. Storm Water Drains in SIDCO nagar require heavy desilting and Chennai Corporation should complete the work before monsoon
- Huge corruption appears to have taken place in the widening of Buckingham Canal from 20 metres to 100 metres under the JNNURM. This canal is the only drain for all the water collected in the Pallikaranai area. The non-completion of this work was one of the primary causes of flooding in the Pallikaranai area. Immediate

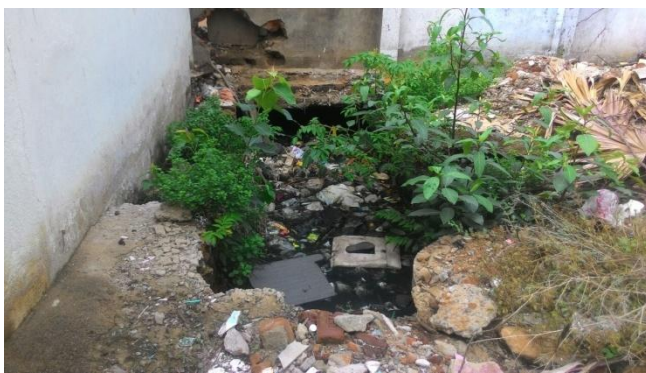
Condition of Storm water drain on 2nd main road

- Storm water drains (SWD) of the entire area including SIDCO Nagar and South Jaganatha Nagar were audited. The storm water drains were in terrible condition during the floods and water didn’t flow through it. Even now, the storm water drains are completely choked up with silt, garbage and debris at many places. They have also been encroached by shops at some places. Here is a list of all points on SWDs in SIDCO Nagar

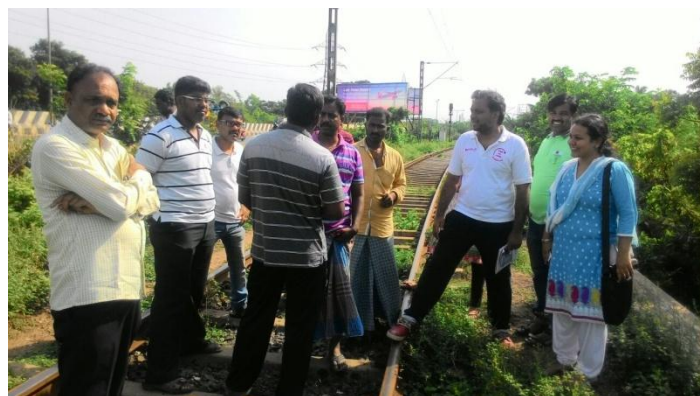
Social audit by volunteers

- (SWD) are available on either side, measuring 6 feet and 4 feet deep, encroached by shops
- The storm water drains are open at many places in SIDCO Nagar leading to dumping of debris and garbage.

- SWD situated opposite the sewage pumping station is filled with debris
  - SWD situated near the sewage pumping station is damaged
  - The SWD in the industrial estate is 4 feet wide, it is damaged and filled with debris

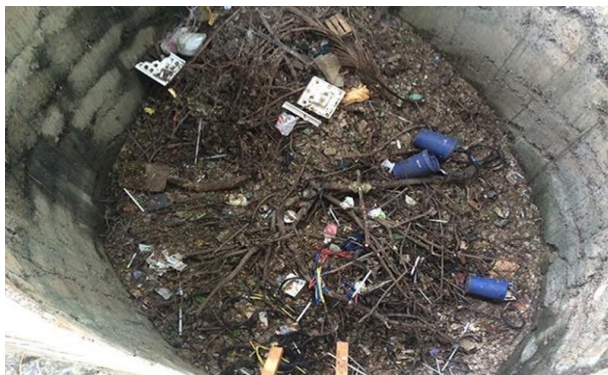
- Apart from this, sewage/industrial waste from the Padi and TVS side is discharged into the otteri nallah drain without any treatment
- SIDCO Nagar has 7 wells dug by Chennai Metro Water. All 7 are abandoned now. One of the wells and the adjacent land is used by Chennai Metro for official purposes but other wells remain as garbage dumping areas. SIDCO Nagar association residents want the excess rain water to flow into the wells so as to recharge ground water. They also want the land adjacent to be used as part of a walkway. Their

**Unused well of the Metro water**

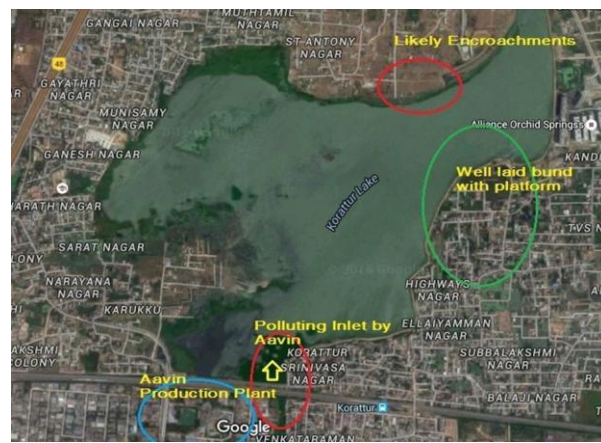
- SWDs are clogged with encroachments and blocking water from Ambattur and mosque side
- The Korattur lake near Villivakkam lake was also audited. The east side of the lake is well secured with bund and platform; whereas west side is left open and is prone to encroachment. At the North east side, there is a madhagu that takes excess water to Retteri lake. At the southern side, the lake is polluted by effluents from Aavin production plant

Korattur lake

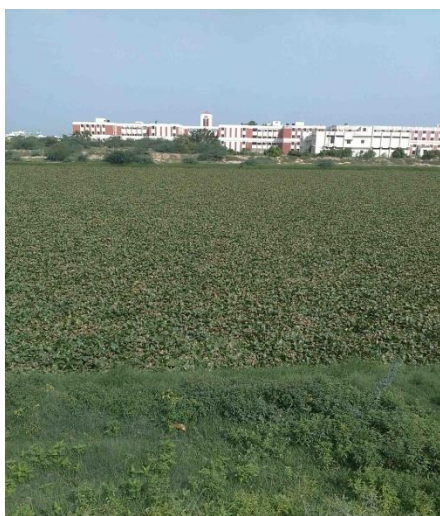
- Garbage from small industries, houses and a small paper industry are all dumped in the Okkiyam Madivu stretch near Thangavelu Engineering College.
- Sewage from the surrounding areas is also let directly into Okkiyam madivu without treatment at the OMR Okkiyam Madivu intersection
- While one side of Okkiyam Madivu is reasonably maintained, the other side does not even have approach road. The KC tech college’s walls prevent accessing one side of the Okkiyam Madivu.

Okkiyam Madivu-Buckingham joining point

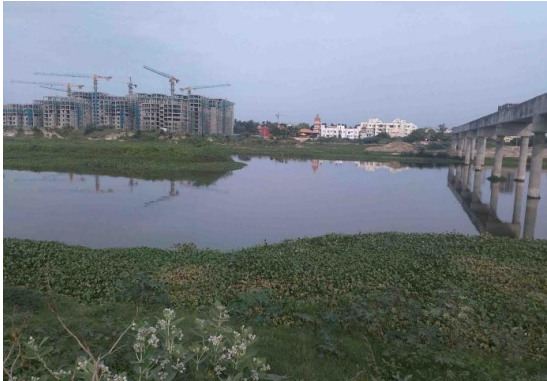
- 2.4 Kms from the starting point, the Buckingham canal has a big bund running in the middle, for a length of 10 km, parallel to the banks that has not been cleared at all. The canal has been extended only for a width of 19 m on average along this entire stretch. On one side of the bund the width was earlier around 24.5 m which has now become around 44 m.

After 2.4 Kms, the bund in between remains

informed that the PWD only dredged the two ends of the canal forming a bund in the middle which has not been cleared. The canal supposedly is 12 ft deep only at the ends and not throughout as it ought to be.

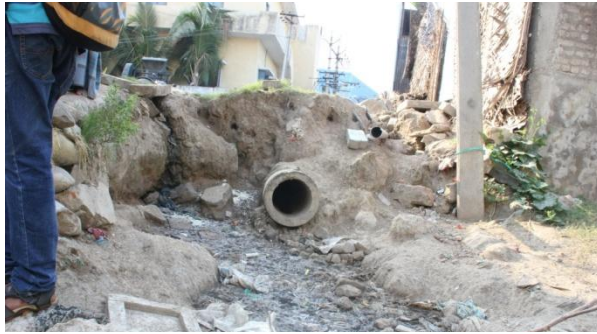
**Metro water’s pipeline into canal to discharge untreated waste**

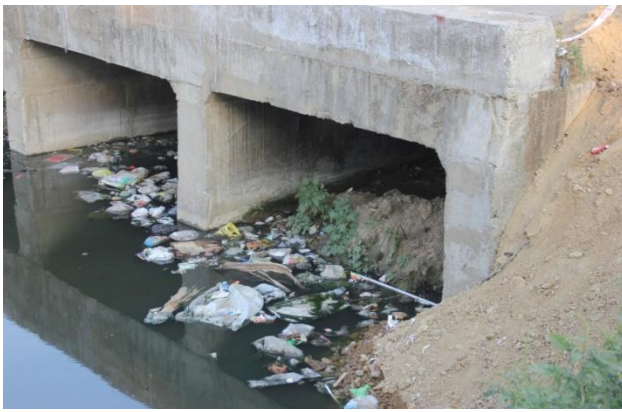
**At radial road intersection**

- The entire stretch is clogged with garbage, construction debris and heavy encroachment. At the intersection of the arterial road, the situation is even worse as can be seen in the figure above. There is also silt

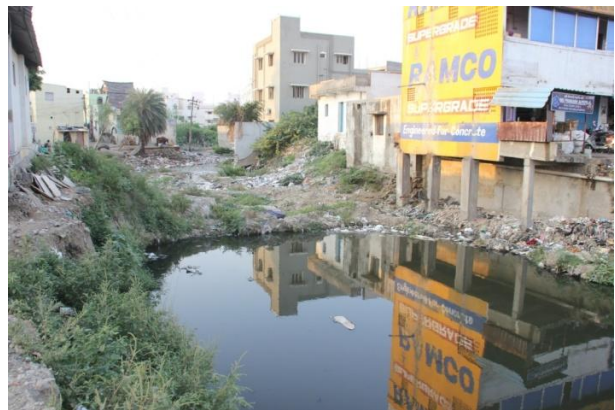
**Encroachment on right and flow in the middle blocked by garbage and debris**

formation and it has been several years since desilting.

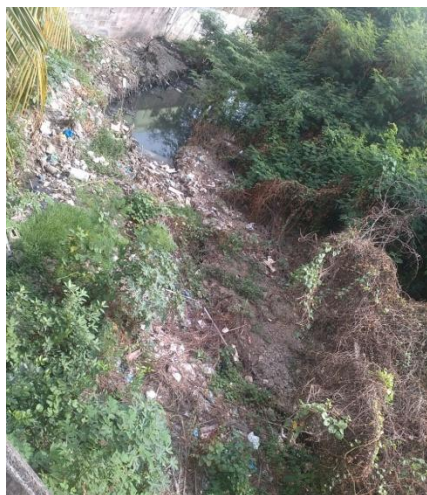
- The original width of the canal is 50 to 60 feet. However, in most places the width is reduced to 15 to 40 feet and the actual water flowing width is reduced to anywhere between 3 to 30 feet.
- The entry point was closed by AAI so there is no provision for water going through AAI canal after the December 2015 flood.
- After the Panchayat of Mugalivakkam was attached with Chennai Corporation, a SWD measuring 3 feet by 3 feet was built to divert the water outside AAI canal
- The water inflow is huge in the street and outflow is very low. The storm water drain constructed is suitable for low level of rain fall. If the rain continues for 2 days the water will overflow

Mugalivakkam canal near sabari nagar filled with silt

- The Mugalivakkam canal connecting the Airport land and the Adyar river has not been desilted for 15 years now. The silt formation is upto ground level and has resulted in heavy flooding of the area. Desilting of the canal along with removal of garbage and removing encroachments are key to making sure that the area does not see a repeat of last year floods again. The canal that is being closed near MGR house must be restored immediately.

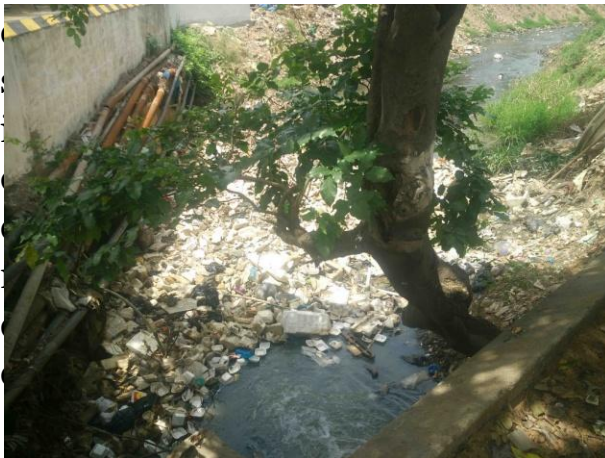
- Near DLF, on ATM Street, the water flow is very slow and lot of garbage is dumped on this part of the canal.
- After crossing the road, before MIOT, in front of the Late MGR's

Canal choked with garbage

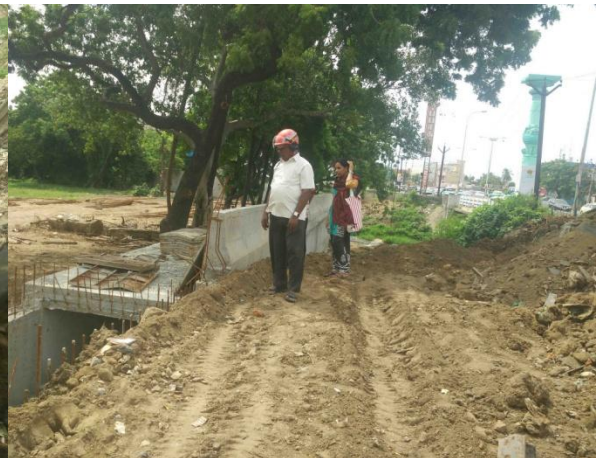
Canal being closed down with sand near MGR house

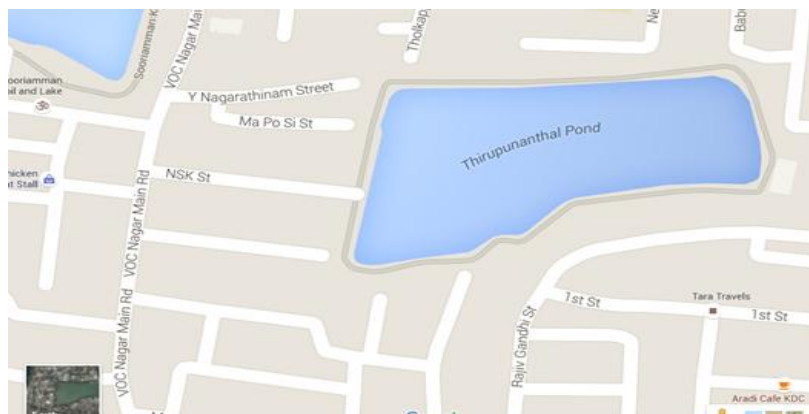
The places surrounding Thirupananthaal lake were flooded heavily. Thirupananthaal lake is situated in Krishna Nagar, Pammal near Pallavaram. The lake has been heavily encroached over the years and reduced more than 80% over the last 4 decades. This lake is critical both for water storage as well as flood prevention as this is one of the few remaining lakes in the area apart from Sooriyamman lake. Many lakes such as Moongileri have been filled up by the Government and housing units have been built on top of it.

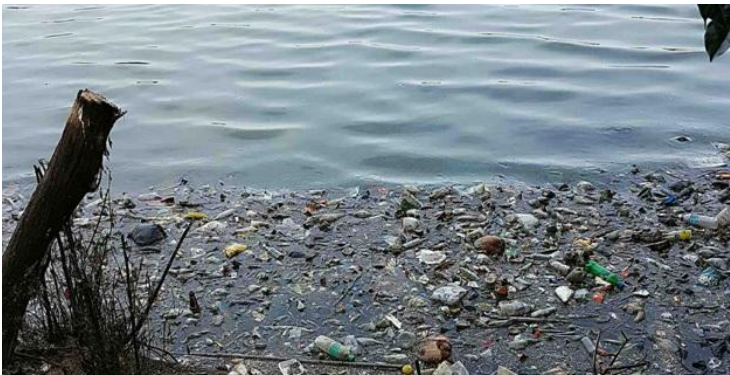
Thirupananthaal lake

- The outlet from the Tirupananthal lake into the channel at the north east of the lake is completely choked up with Garbage. Plastic waste is blocking the flow of water into the channel.

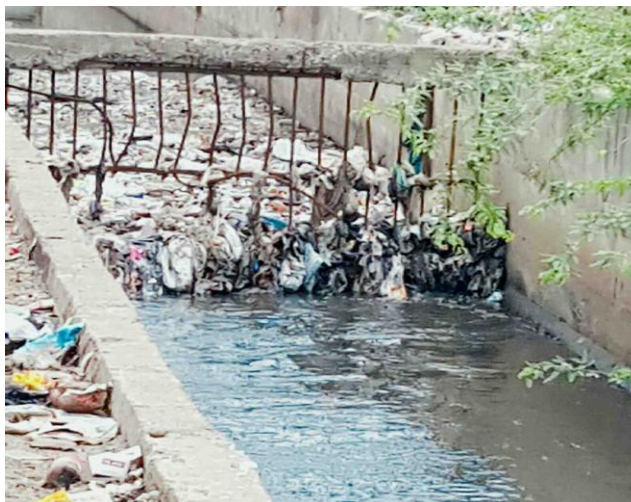
- The channel ends here and the overflow from here is diverted into 2 very small channels of 2 to 3 feet wide and 4 to 5 feet depth. The condition of these two channels is extremely poor choked with sewage and garbage with no maintenance.

Canal flow blocked with garbage  
near Cowl Bazar

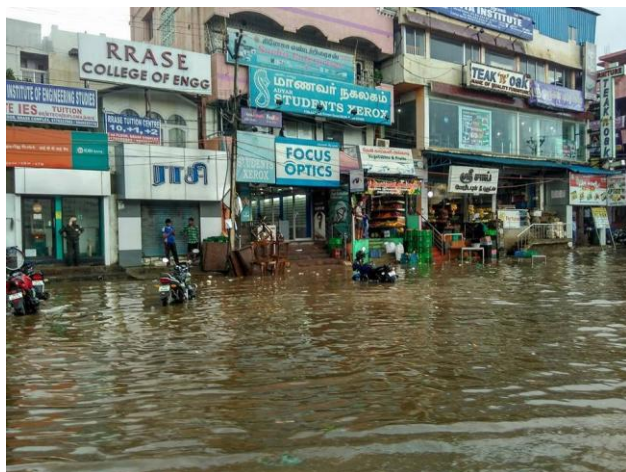
**GST Road during floods near Chrompet police station**

On the GST road near Chrompet, there was heavy flooding in December 2015. The road is flooded almost every monsoon. The audit looked at the channels connecting the Chrompet area to the Pallavaram Periya Eri. The canals connecting into the Periya Eri used to have original width of anywhere between 30 to 60 feet originally.

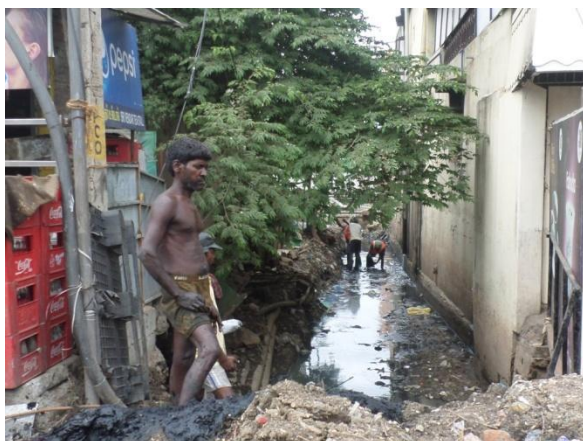
**GST Road canal near police station**

also opposite to Chrompet police station are very shallow and the width is very narrow

- For the Chrompet to Pallavaram Periya Eri canals, the culverts under the GST and under the railway tracks must be widened immediately. The encroachments that narrow the canal to less than 20 feet must be cleared immediately and garbage blocks need to be removed. Pallavaram municipality must stop dumping garbage at the Pallavaram Periya Eri.

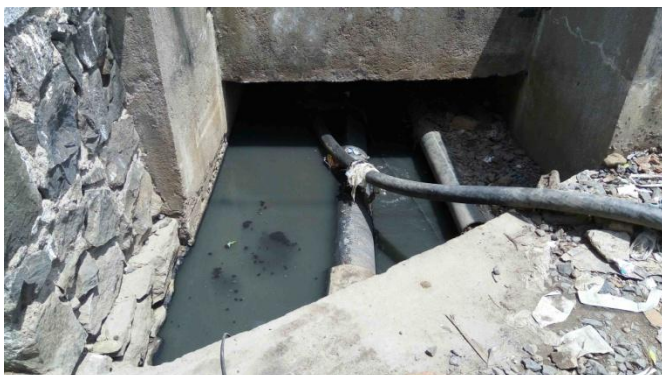
Culvert under the railway track

- These 2 channels cross the railway tracks by way of 3 to 4 feet culverts. Other water pipelines and cables also pass through the same culverts. These 2 channels join at Shanti Nagar in Chrompet on the east and this canal into Periya Eri at Pallavaram.

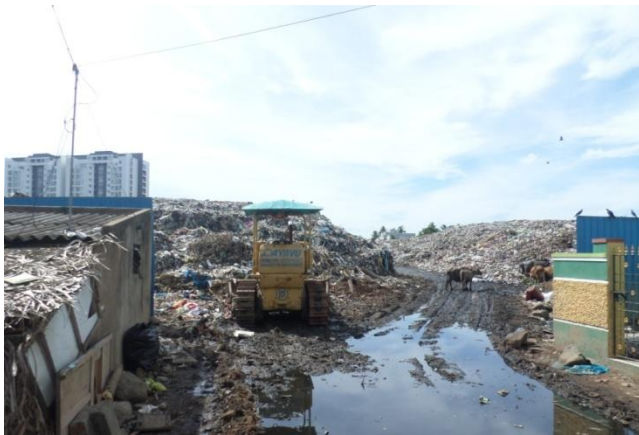
- The narrow width then expands into 10 to 12 feet and reaches the Pallavaram Periya Eri. The Pallavaram Periya Eri on the Chrompet side has been heavily encroached (about 70%) by residential houses and the Pallavaram Municipality uses 20% of the Eri as a garbage Dumping yard

Periya Eri dumpyard
